# City Council Committee Meeting Agenda

## Parks and Trails Advisory Committee

## Introduction

**CHURCH CREEK SITE ASSESSMENT**  
STANWOOD TRAIL DESIGN AND MANAGEMENT PLAN

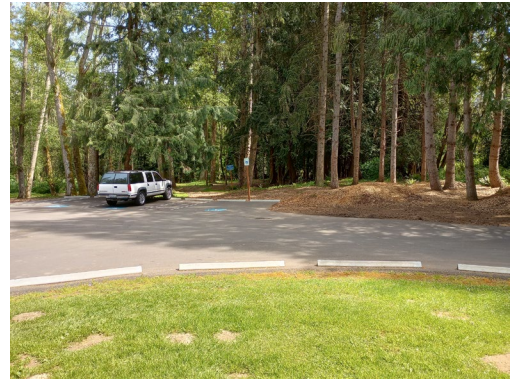
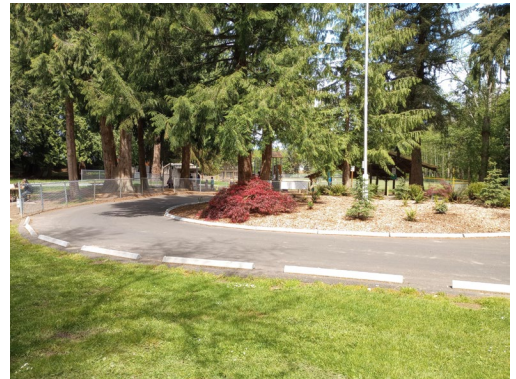
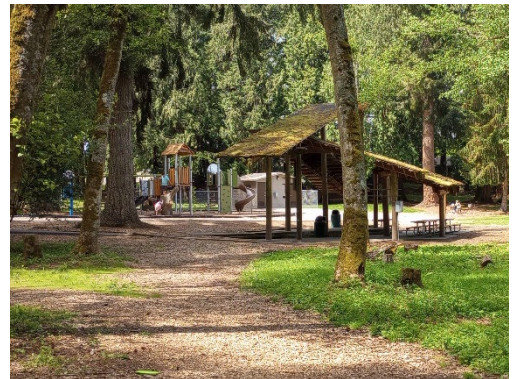
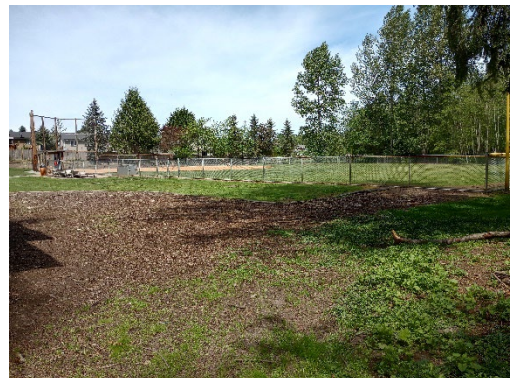
The largest features in the Developed Park Zone are the parking lot, cul-de-sac, play area, baseball field, and open lawn. An asphalt path connects the ADA parking and cul-de-sac to a picnic shelter. North of the picnic shelter is the play area and basketball court. To the northeast of the picnic shelter is the baseball field. All of these park features are connected by an open area with a woodchip surface. Church Creek Trail becomes a wide woodchip path at the southeast corner of the picnic shelter and heads south toward the animal proof trash bin before turning east in the Forest Glade, Zone 2. Disc Golf basket for hole 3 and tee pad for hole 4 are located south of the asphalt pathway near the picnic structure.

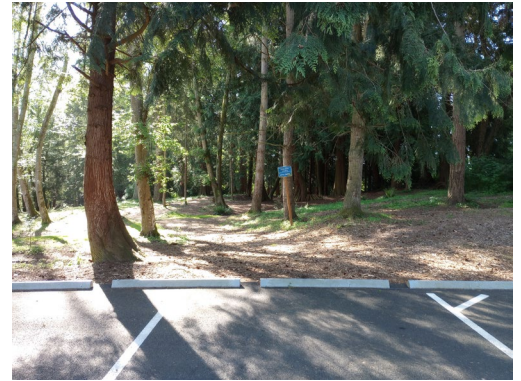
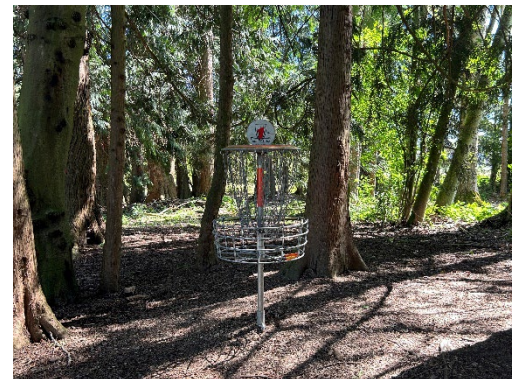
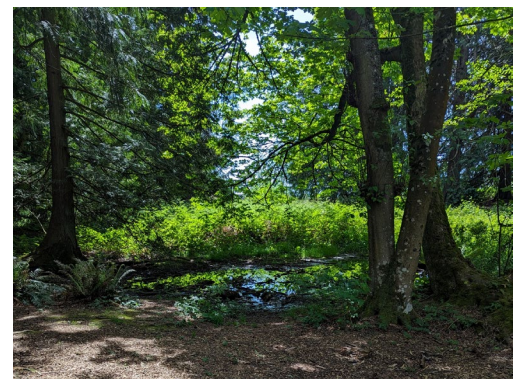
The forest glade is relatively flat with an approximate 0% to 8% slope. The western portion of this zone slopes gently to the south draining in a sheet flow toward the neighboring property. The eastern portion of the zone slopes gently eastward toward Wetland D. Wetland D can be observed to the north of the path. To the south of the path, Wetland A can be seen on the Cedarside Commons property. Wetland A has open water with a drainage that flows along the south property line into a ravine toward Church Creek. Volunteers have created a crossing over this drainage made from downed branches and wood chips to access Golf Disc holes 2 and 8. The crossing has decomposed and is blocking the drainage.

Several alternate trail access points are located along the south edge of the ADA parking stalls. The open understory, with multiple overlapping trail routes, makes identifying the trail challenging. These routes merge with a main trail near an animal resistant trash bin. At this point the trail turns east along the property line and appears to cross the southern property line near Disc Golf holes 4 and 7. However, it is unclear where the south property line actually runs as it is not demarcated.

The existing Disk Golf holes 1, 2, 8 and portions of 3, 4, and 9 run through the Forest Glade. Holes 2, 7, and 8 are located on the Cedarside Commons property. A survey for the new development indicates baskets for holes 4 and 7 are on the Cedarside Commons property. Hole 9 tees off in the Forest Glade, Zone 2, at the edge of the ravine and its basket is located lower on the slope within the ravine, in Zone 3.

1. Zone 2: The existing Church Creek Trail route potentially crosses the south property line and travels off park property between Disc Golf hole 4 and 9.

2. Zone 2: The potential viewpoint area that was discussed is where Disc Golf tee pad 9 is currently located. Survey documents for Cedarside Commons identify tee pad 9 as being very near and adjacent to the south property line. Given the available topography, placing a viewpoint in this location could cross the property line.

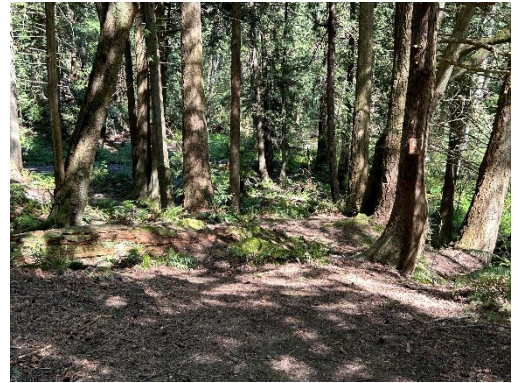
The ravine is typified by steep slopes ranging from 8% to 65%. Rainwater from the site drains to Church Creek. The GIS Contours indicate three drainageways. The first captures water coming from the north property line and the edge of Church Creek Estates. The second captures water from Wetland D near the Alder Glen. The third drainageway captures water from the south end of Wetland D, Wetland E and Wetland A located on the Cedarside Commons property.

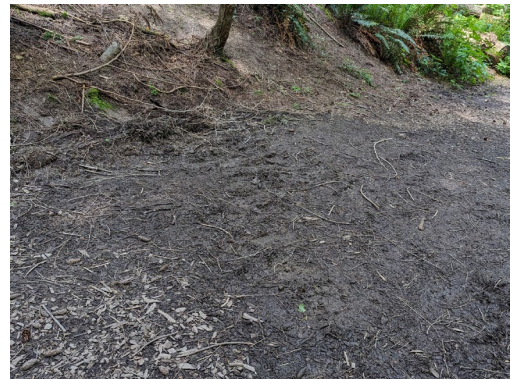
The soils are documented as Tokul-Winston gravelly loams. They are generated by loess, volcanic ash deposits, and glacial till cemented with iron and manganese as well as glacial outwash or old alluvium mixed with loess and volcanic ash. They are moderately well drained to well drained with slow to medium run off. The soils support a variety of plant life and the slopes in the ravine are well vegetated with western red cedar, big leaf maple, salmonberry, ninebark elderberry, ferns.

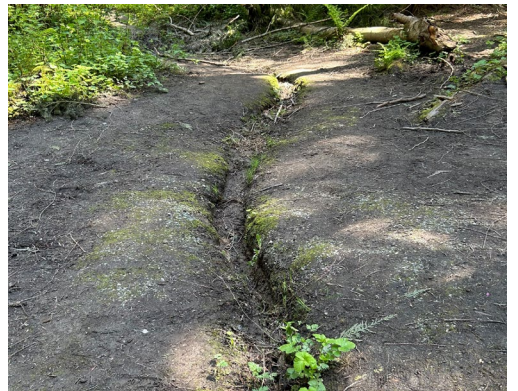
Just after hole 7, Church Creek Trail starts down into the ravine. To the right (south) side of the wide woodchip path is the tee for Disc Golf hole 9. It sits at the top edge of the ravine near the southern property line. In winter, this location has views of the creek. Though this area may exist directly on or adjacent to the south property line.

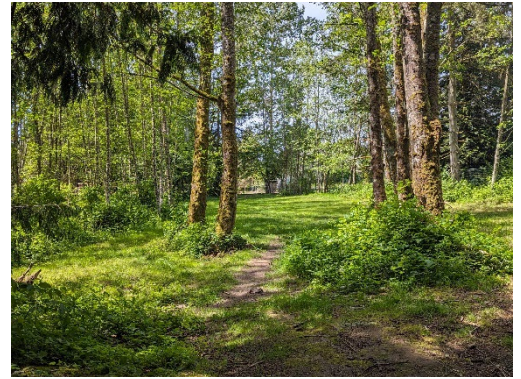
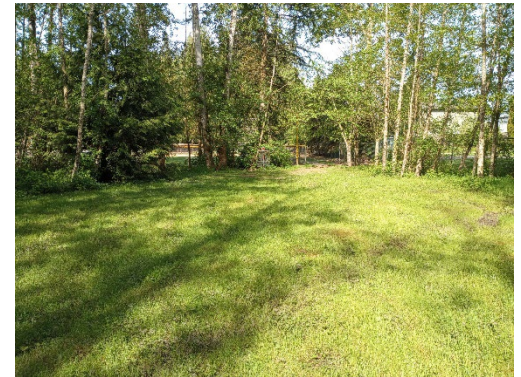
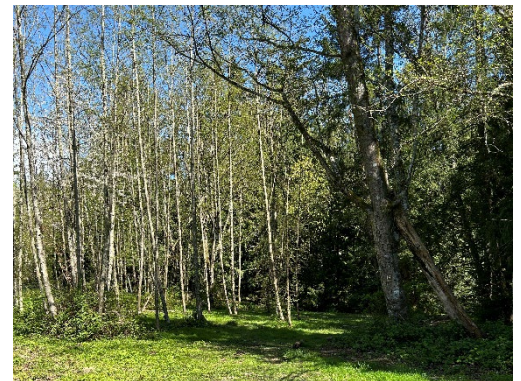
This zone is bordered by a chain link outfield fence to the west, a chain link fence at the edge of Church Creek Estates to the north, the ravine to the east and the central wetland to the south. Alder Glen is accessed primarily by Disc Golf players and the open grassy area is kept mown. When playing Disc Golf enthusiasts enter Alder Glen by following fairways 14 and 16. At the edge of the ravine a stamped earth path fades into grass. The only indication of a trail through the Alder Glen is the Disc Golf tee pads and baskets for holes 14 and 16.

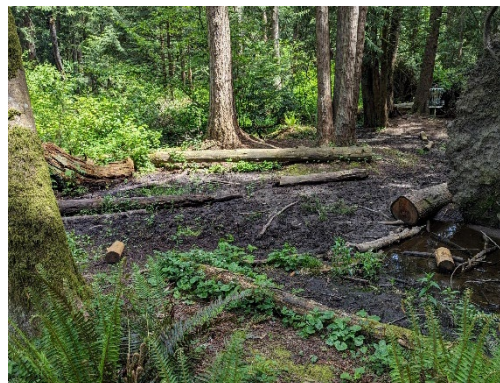
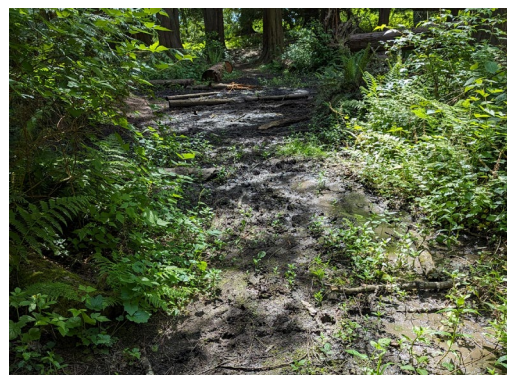
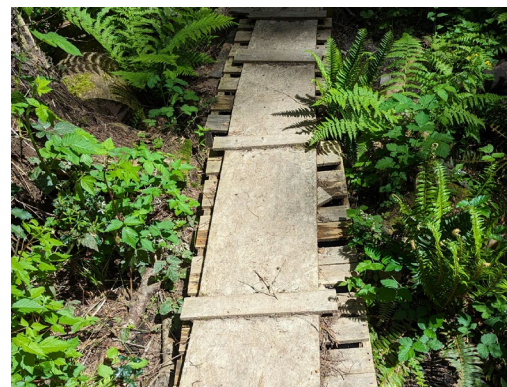
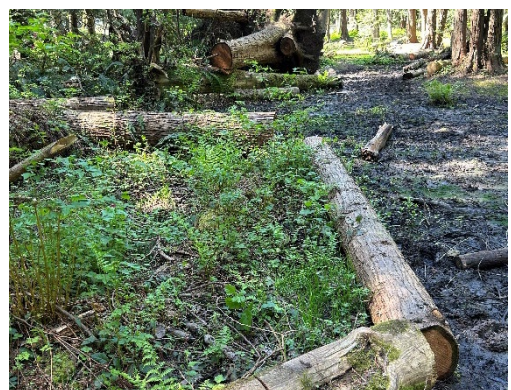
The only existing infrastructure in this zone are Disc Golf holes 6, 11, 12, and 13. Tee pads and the baskets for each hole are located on dry soil outside the wetland boundaries, but within the wetland buffer. Logs have been cut and shifted to delineate walking paths and to indicate hole fairways through Wetland D boundary. A raised, narrow footpath made of wood pallets is located between holes 12 basket and hole 13 tee.

6. Zone 5: The disc golf fairways inside the boundary of Wetland D show heavy disturbance of wetland soils and impact to wetland vegetation caused by downed logs, construction of pathways, and focused foot traffic.

7. Zone 5: Disc Golf fairways inside Wetland D downgrade the condition of the Disc Golf course for players.
