**City Council Committee
Meeting Agenda**

Public Works / Parks Committee

**CITY OF STANWOOD
PUBLIC WORKS COMMITTEE
AGENDA STAFF REPORT**

Multi-Modal Level of Service

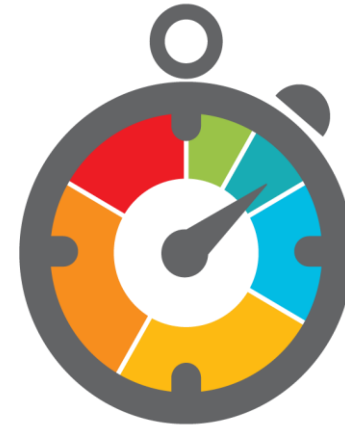
Roadway
Volume-to-Capacity
(vehicle throughput)

Intersection Delay/
seconds per vehicle
(driver inconvenience)

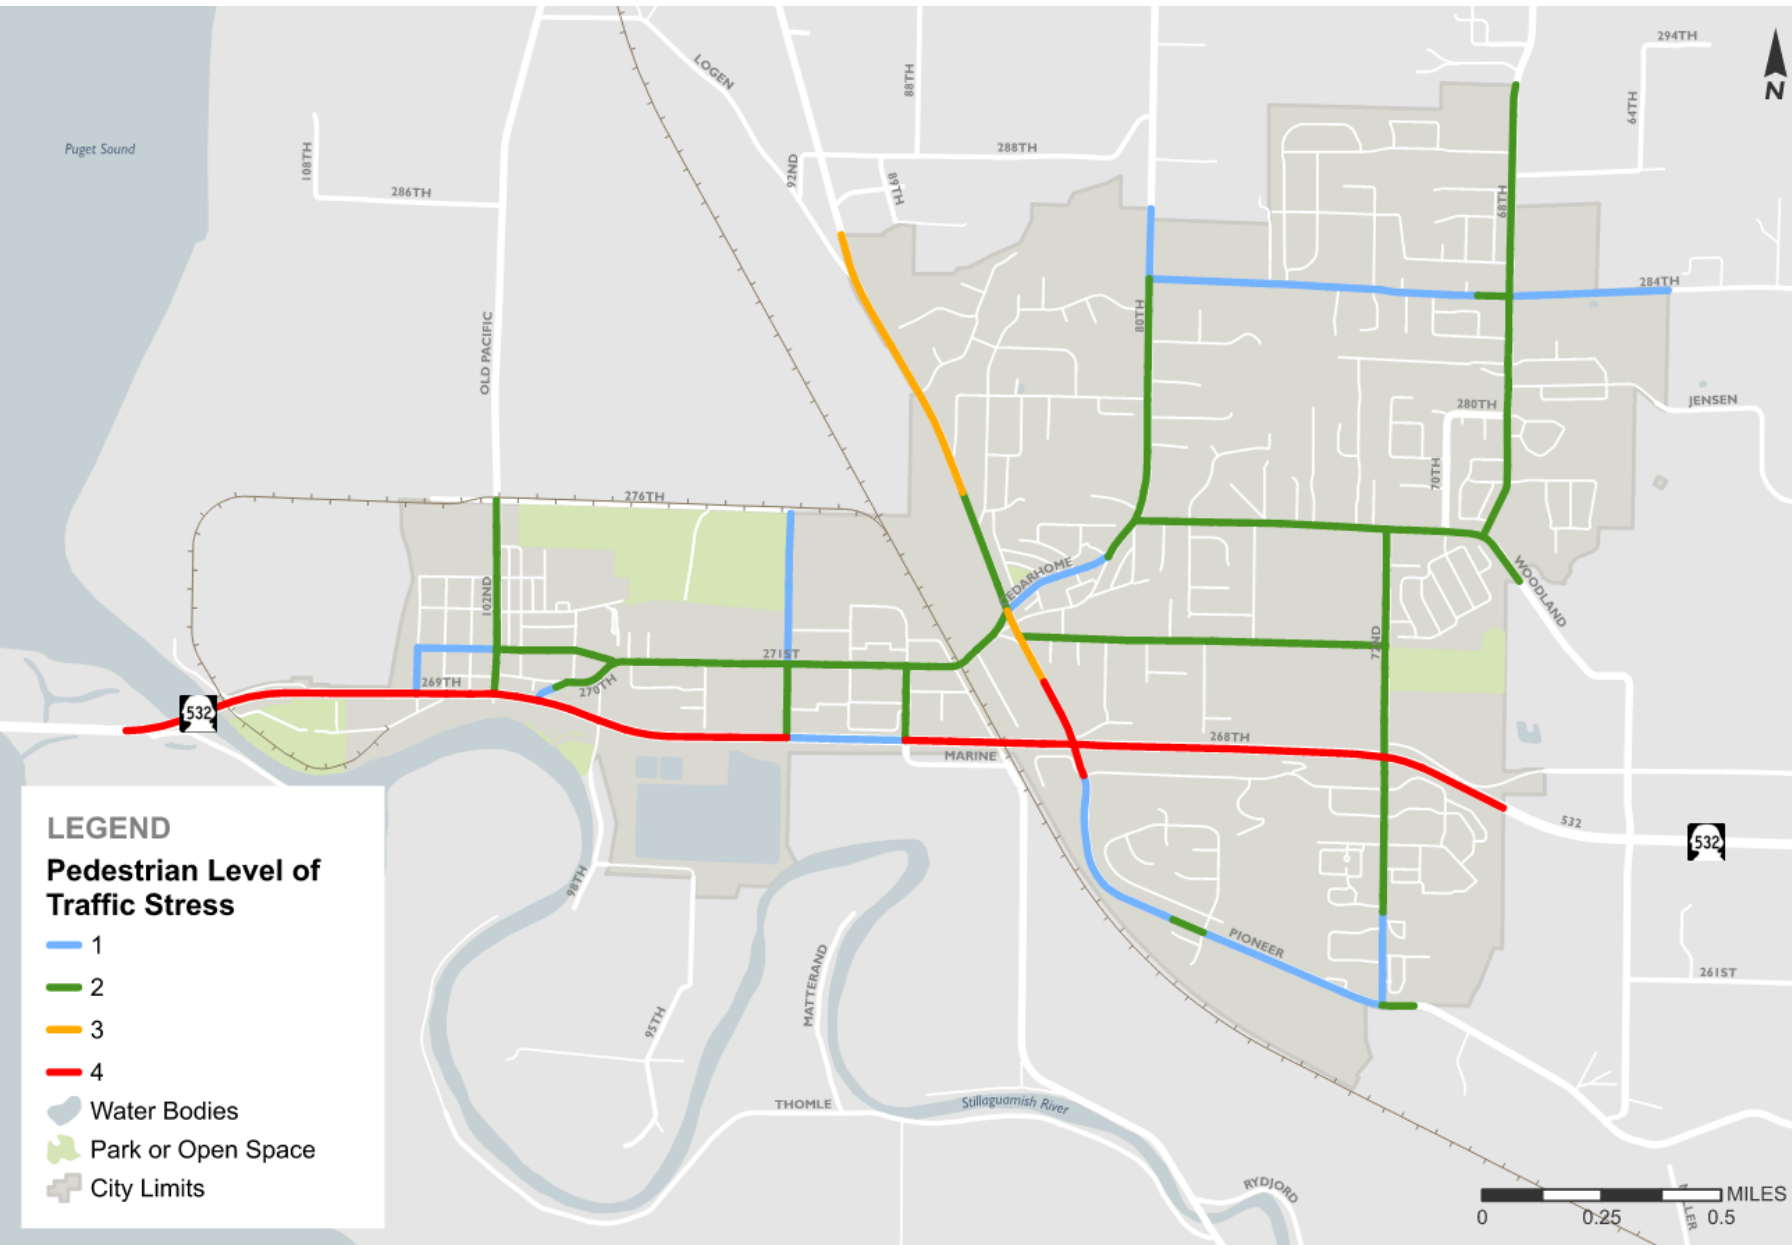
PEDESTRIAN LEVEL OF TRAFFIC STRESS

- LTS 3 and 4 would be considered 'failing'
- LTS can be improved by lowering speeds or adding facilities for pedestrians (sidewalks, multiuse paths, etc.)

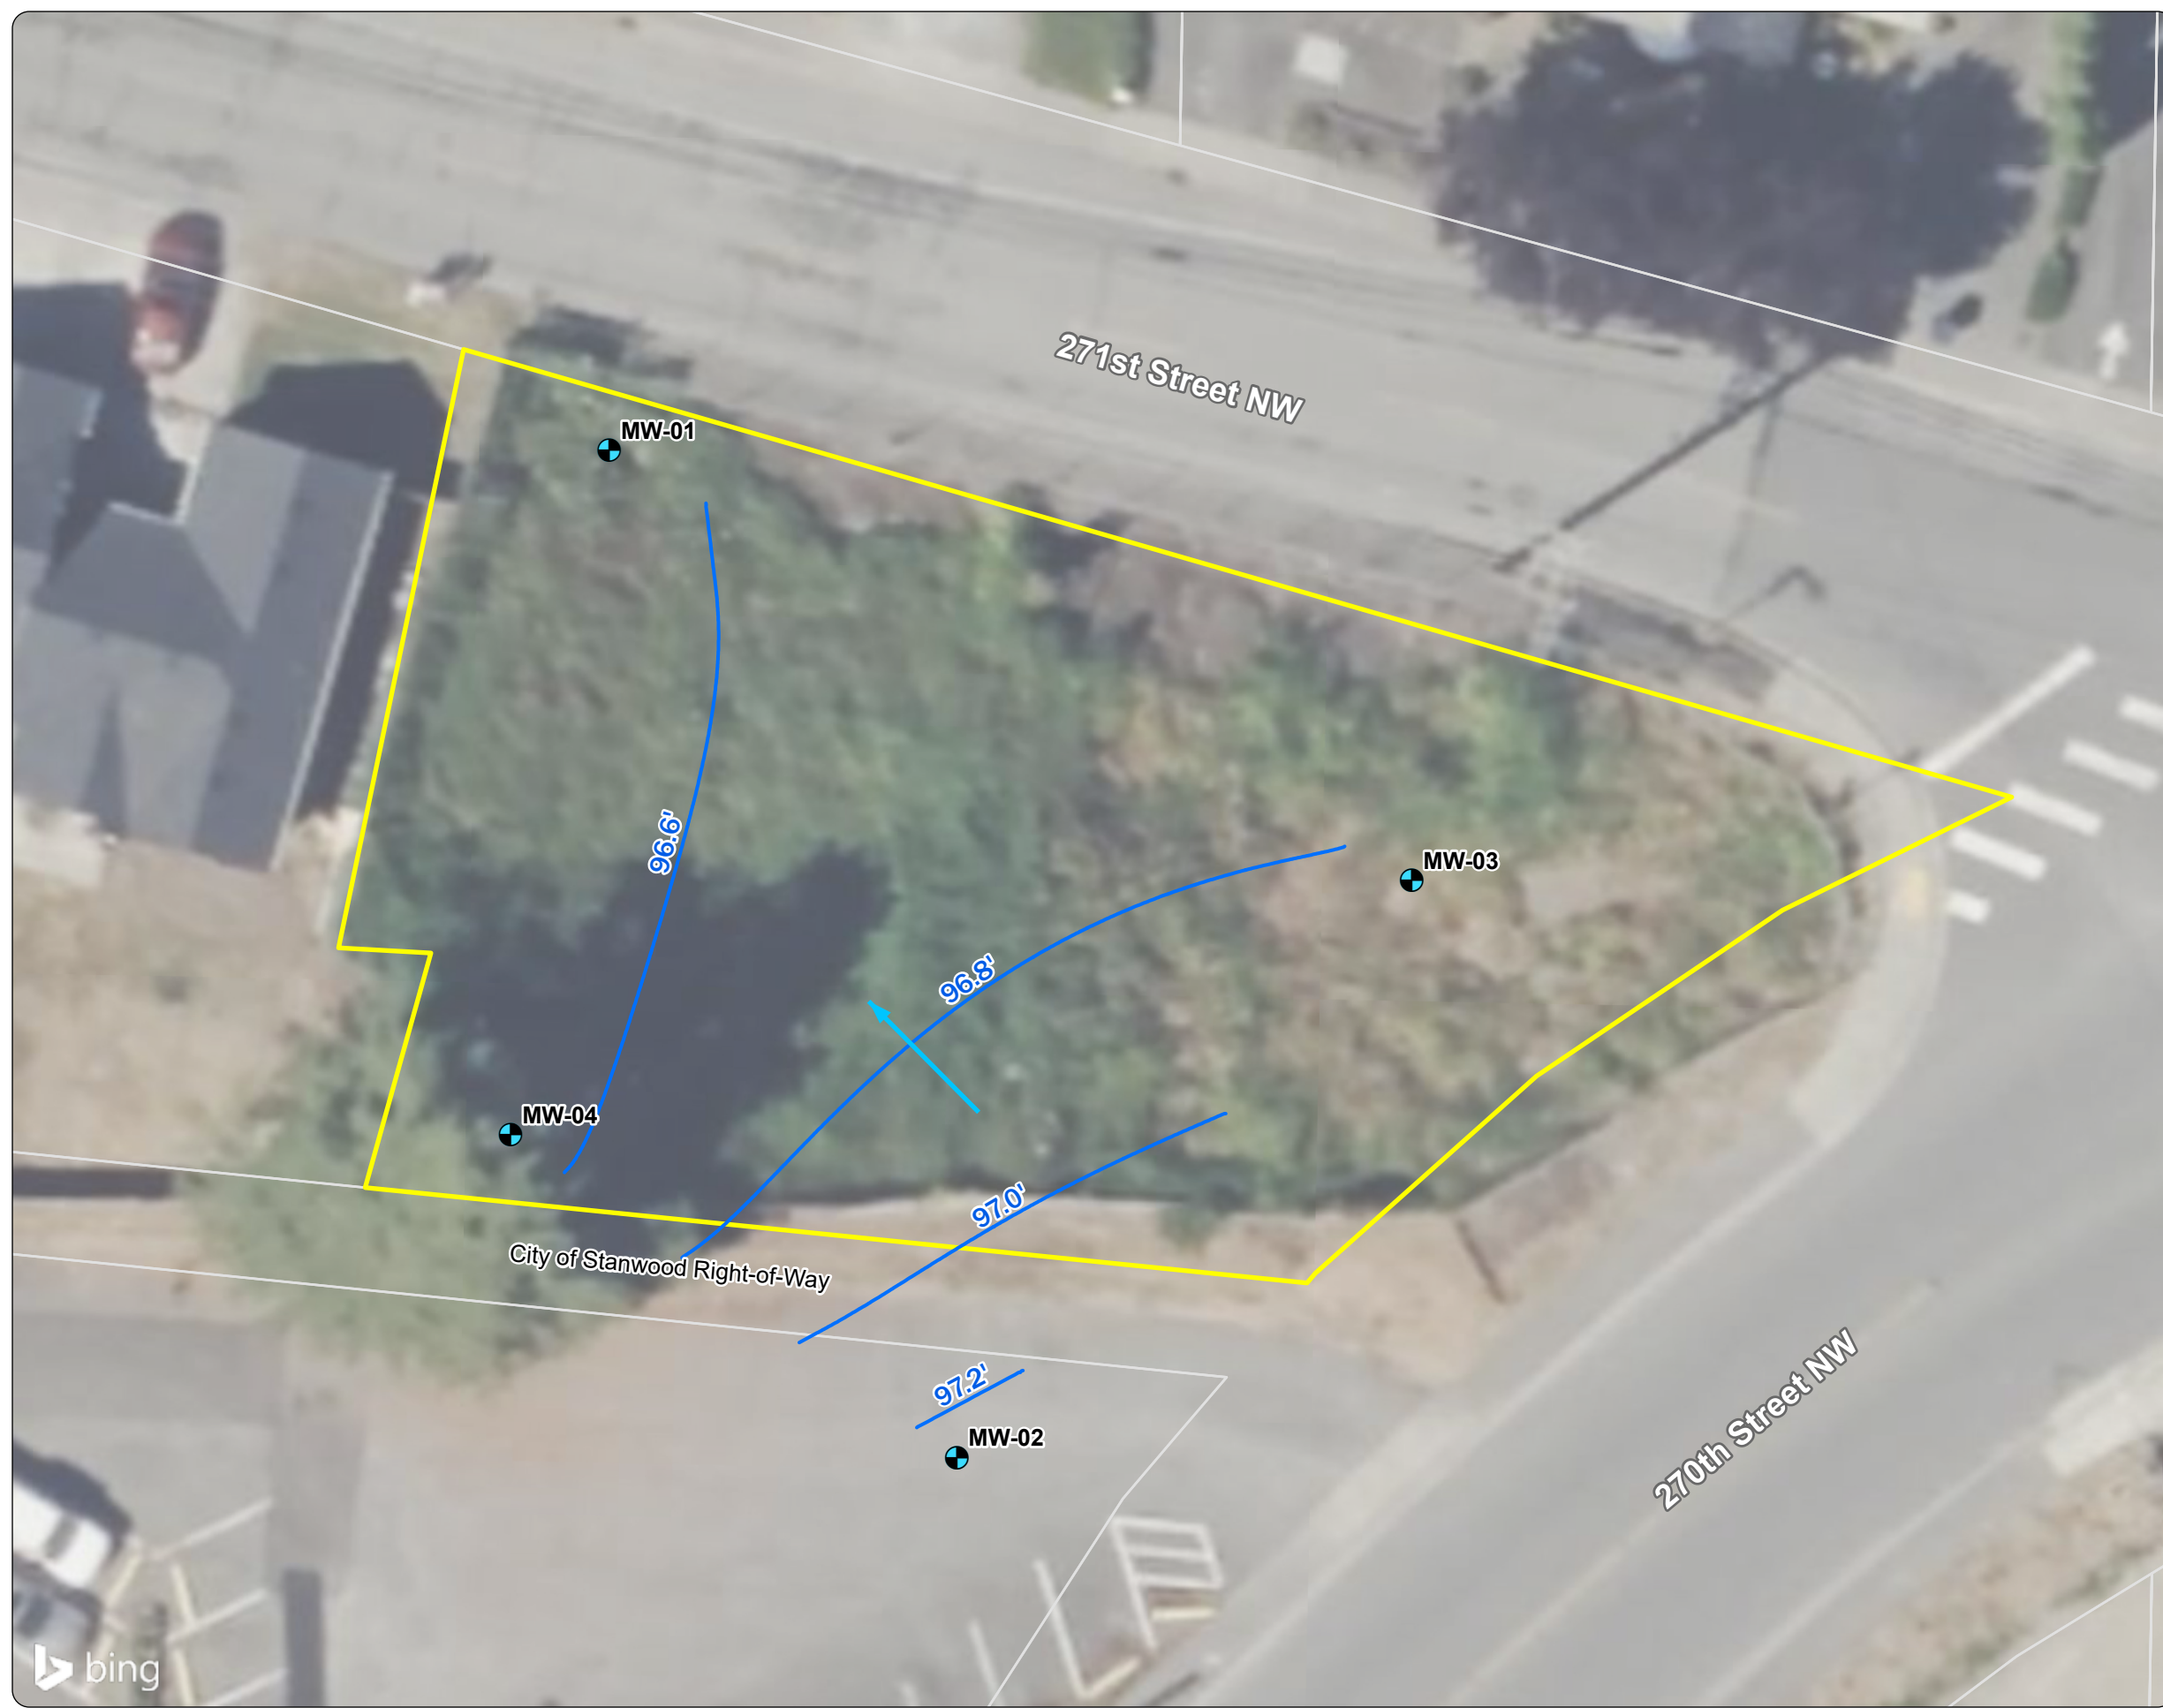
Tax Lot

Notes:
 Depths to groundwater measured between 1:01 pm and 1:27 pm on July 12, 2024.
 All property feature locations are approximate.
 TOC elevations are expressed in feet relative to an arbitrary datum of 100.00 feet at MW-04 SAIC, 2006).
 TOC = top of casing.
