# **City of Stanwood**

## **Stanwood City Council Special Meeting Workshop**

## Site Design Options

## Existing Building and Site Assessment

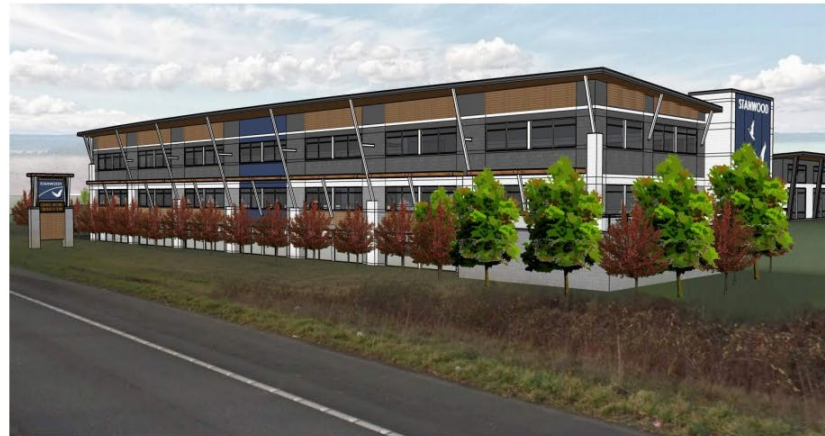
### Stanwood Commons Building – Option 1: Stand Alone Police Station

#### Option #1 Recommended Design Proposal:

Renovate 12,000 sq. ft. of the existing Commons Building for use as City Hall and Council Chambers. Remainder of building is leased to tenants.

The design options were further expanded to include another option with Police in a separate adjacent building. Design option #1 is recommended, as it would eliminate the need for expensive seismic upgrades to the existing building. Instead, a police station in a separate building would have current building code seismic requirements built into its design. The existing building, when used for professional offices, has a different seismic standard that would not require extensive upgrades.

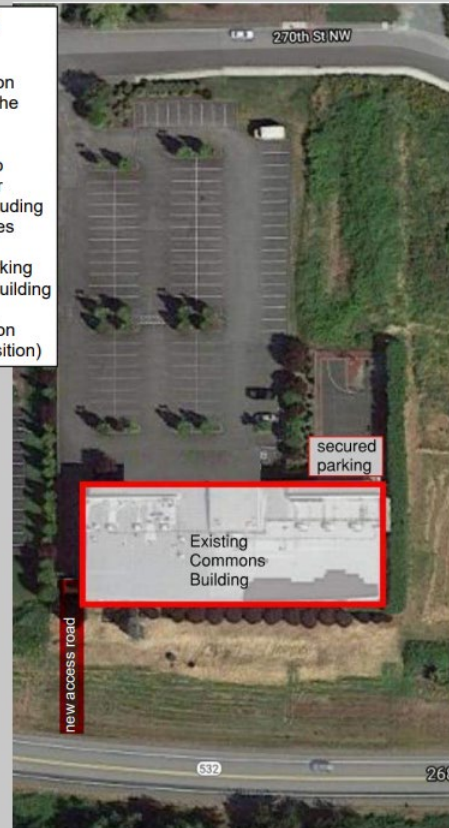
**Option #2 site and building configuration:**

- In lieu of a new Police station building, police is located in the renovated existing building
- Upgrade existing building to emergency operations center seismic design standard, including extensive foundation upgrades
- New Sally Port secured parking garage adjacent to existing building
- Estimated cost: \$20.7 million (does not include land acquisition)

Design option #2 shows the police incorporated into the existing building, with an adjacent new sally port secure parking garage. Due to Risk Category IV seismic design requirements for a police station that is used as an emergency operations center, this design option would require extensive upgrades to the building for seismic reinforcement, including significant foundation improvements.

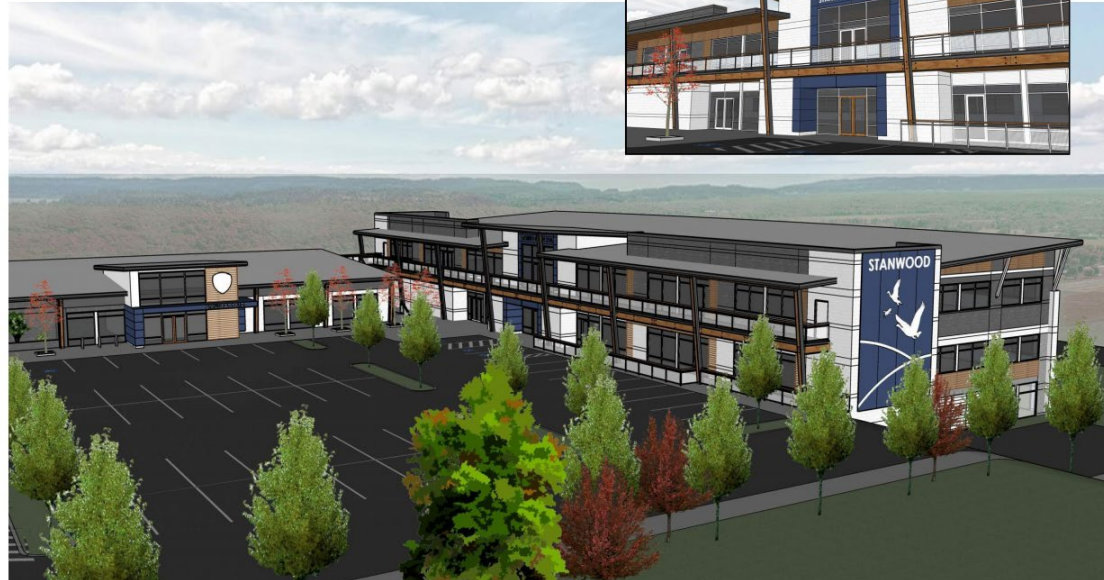
Option #1 Recommended Design Proposal Views

Frontage and side of main building could include the City’s Snow Goose design / art concepts.

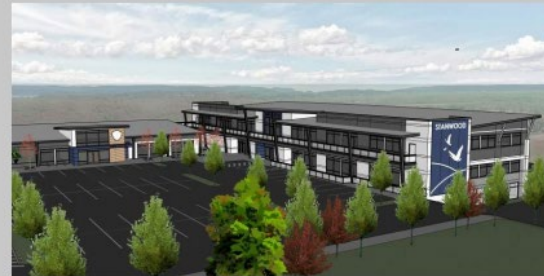
--In lieu of exterior laminate wall panels, paint existing concrete block surface

--Estimated construction savings reduction from option 1 or 2 base: \$455,000

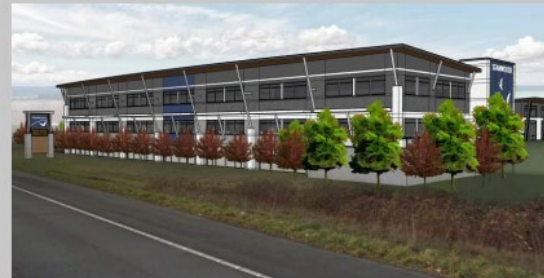
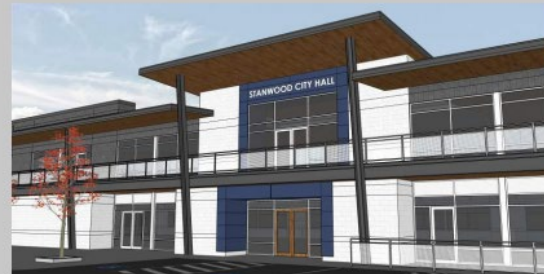
exterior option without laminate wood wall panels

### Alternate without PV panels cost reduction:

--Do not include PV panels and roof load reinforcement

--Estimated construction savings reduction from option 1 or 2 base: \$580,000

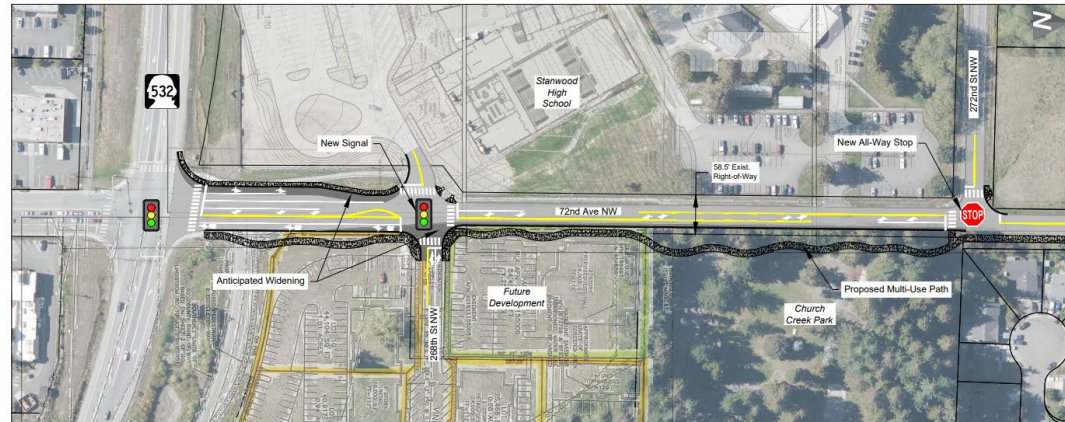
72nd Ave NW - Active Transportation Improvements  
City of Stanwood - SR532 Bypass

### *72nd Avenue Recommended Roadway Configuration:*

TranspoGroup evaluated 72<sup>nd</sup> Avenue at full build out conditions which includes the Vine Street property and the high school traffic. In general, the high school produces two peak use periods: AM and PM for approximately 20 minutes each. Their evaluation concluded that the following roadway improvements could address the traffic congestion issues on 72<sup>nd</sup> Avenue. In addition, the city should consider designing and building the 64<sup>th</sup> Avenue roundabout sooner as that improvement on SR 532 can relieve congestion on 72<sup>nd</sup> Avenue.

SR532 to 272nd St NW  
transpogroup

At the 272nd intersection a traffic signal is not warranted or recommended given the forecasted volumes. An all-way stop is recommended based on a variety of reasons. The primary reason is to control vehicle/pedestrian conflicts in areas with higher volumes of walk and bike trips. This intersection is a primary access point for the new multi-use trail and Church Creek Park area, as well as a major access route for high school students. In addition, traffic volumes for several hours of the day meet all-way stop guidelines. The footprint for the all-way stop and cross-walks would be the same as a traffic signal, so conversion to a future traffic signal would be simple if forecasts assumptions change.

At the 276th intersection no change in traffic control is recommended. Traffic volume warrants and delays do not indicate a need for an all-way stop or roundabout.

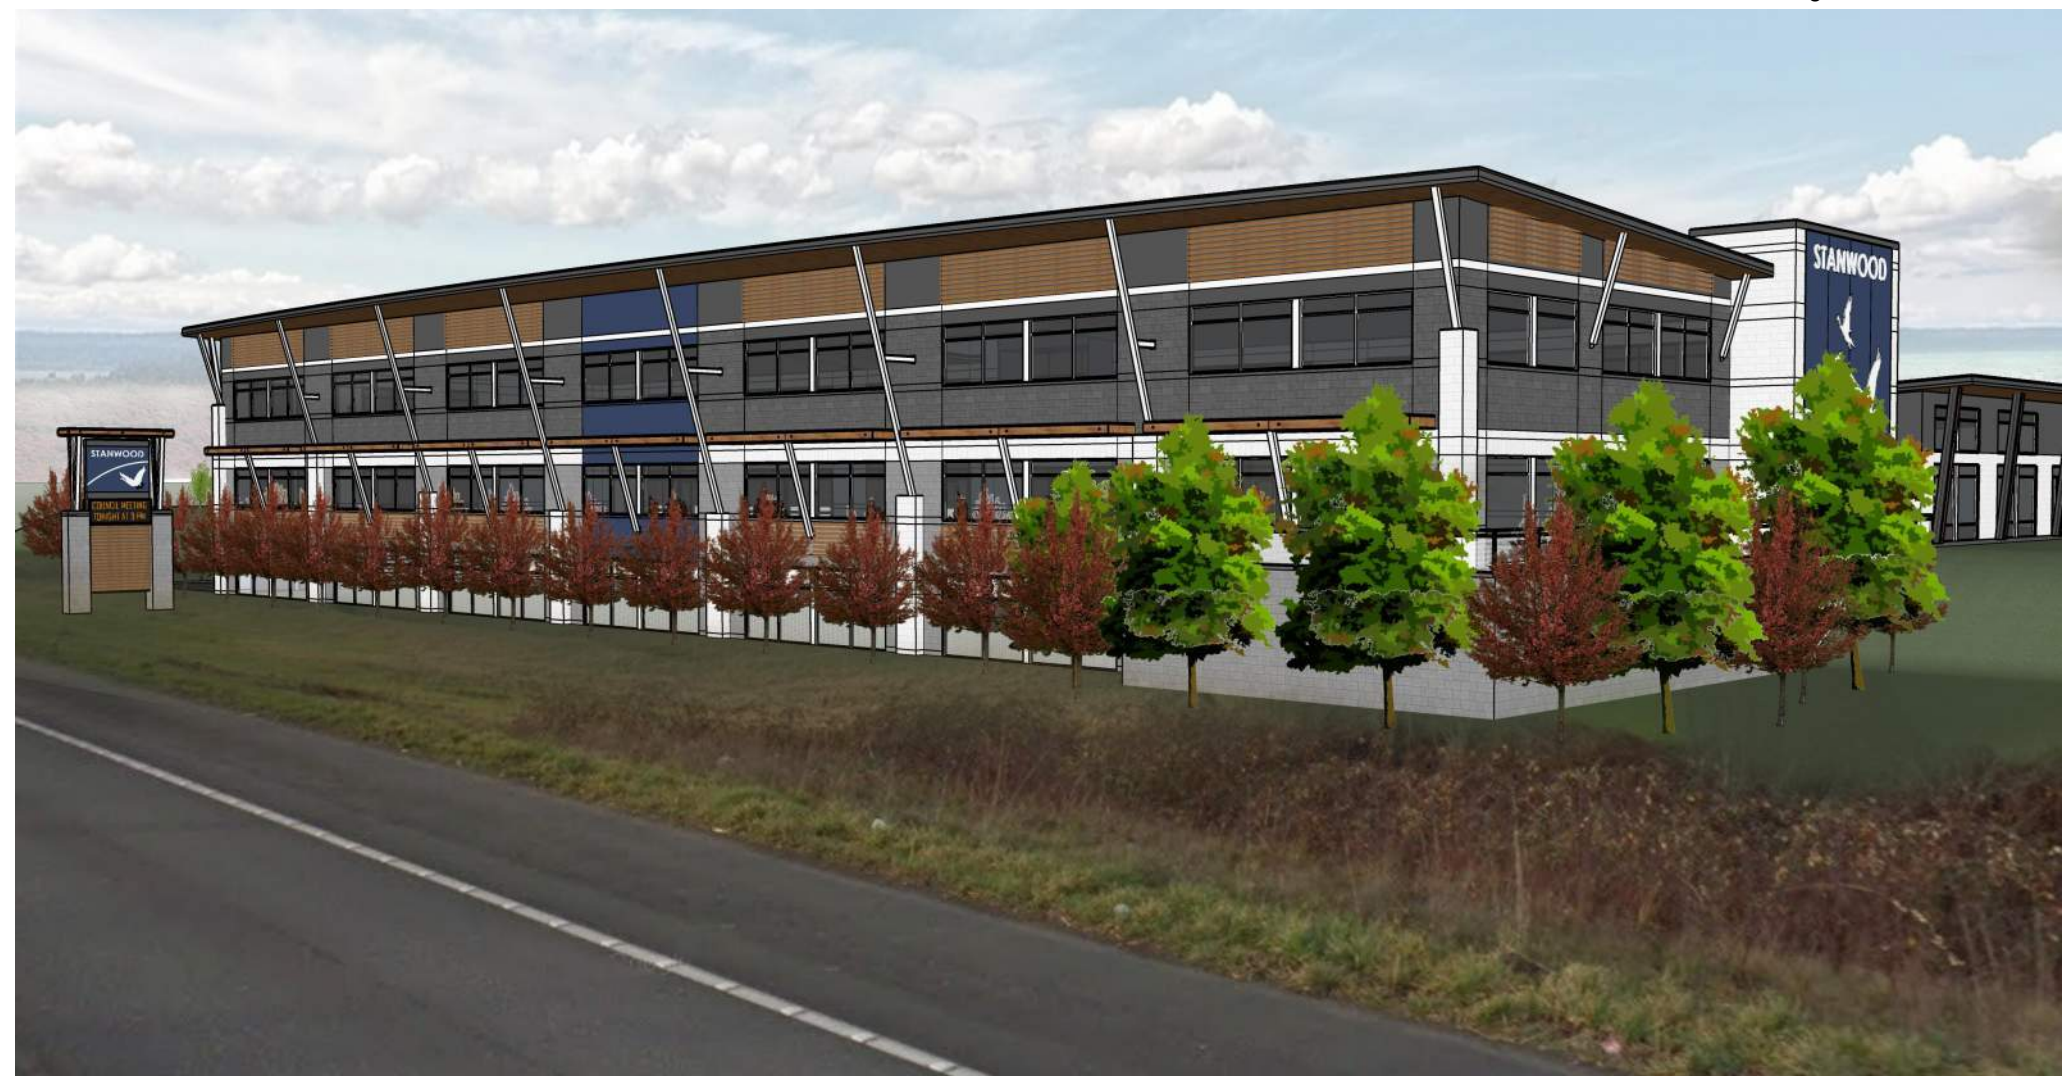
#### Option #1 Recommended Design Proposal:

Renovate 12,000 sq. ft. of the existing Commons Building for use as City Hall and Council Chambers. Remainder of building is leased to tenants.

Estimated Cost: \$16.3 million *(does not include land acquisition)*

- A. New Police Building – 5,000 sq. ft.
- B. New Sally Port secured parking for police.
- C. Renovate existing building area of approximately 12,000 sq. ft. for use as City Hall and Council Chambers.
- D. New photovoltaic panels on existing building.
- E. New roof membrane.
- F. Mechanical, electrical and plumbing upgrades for the renovated spaces.
- G. Site upgrades: repair and upgrade parking lot, upgrade storm water management, add emergency access road.
- H. Exterior updates: paint, metal panels at entrance, signage, and laminated wood accent panels

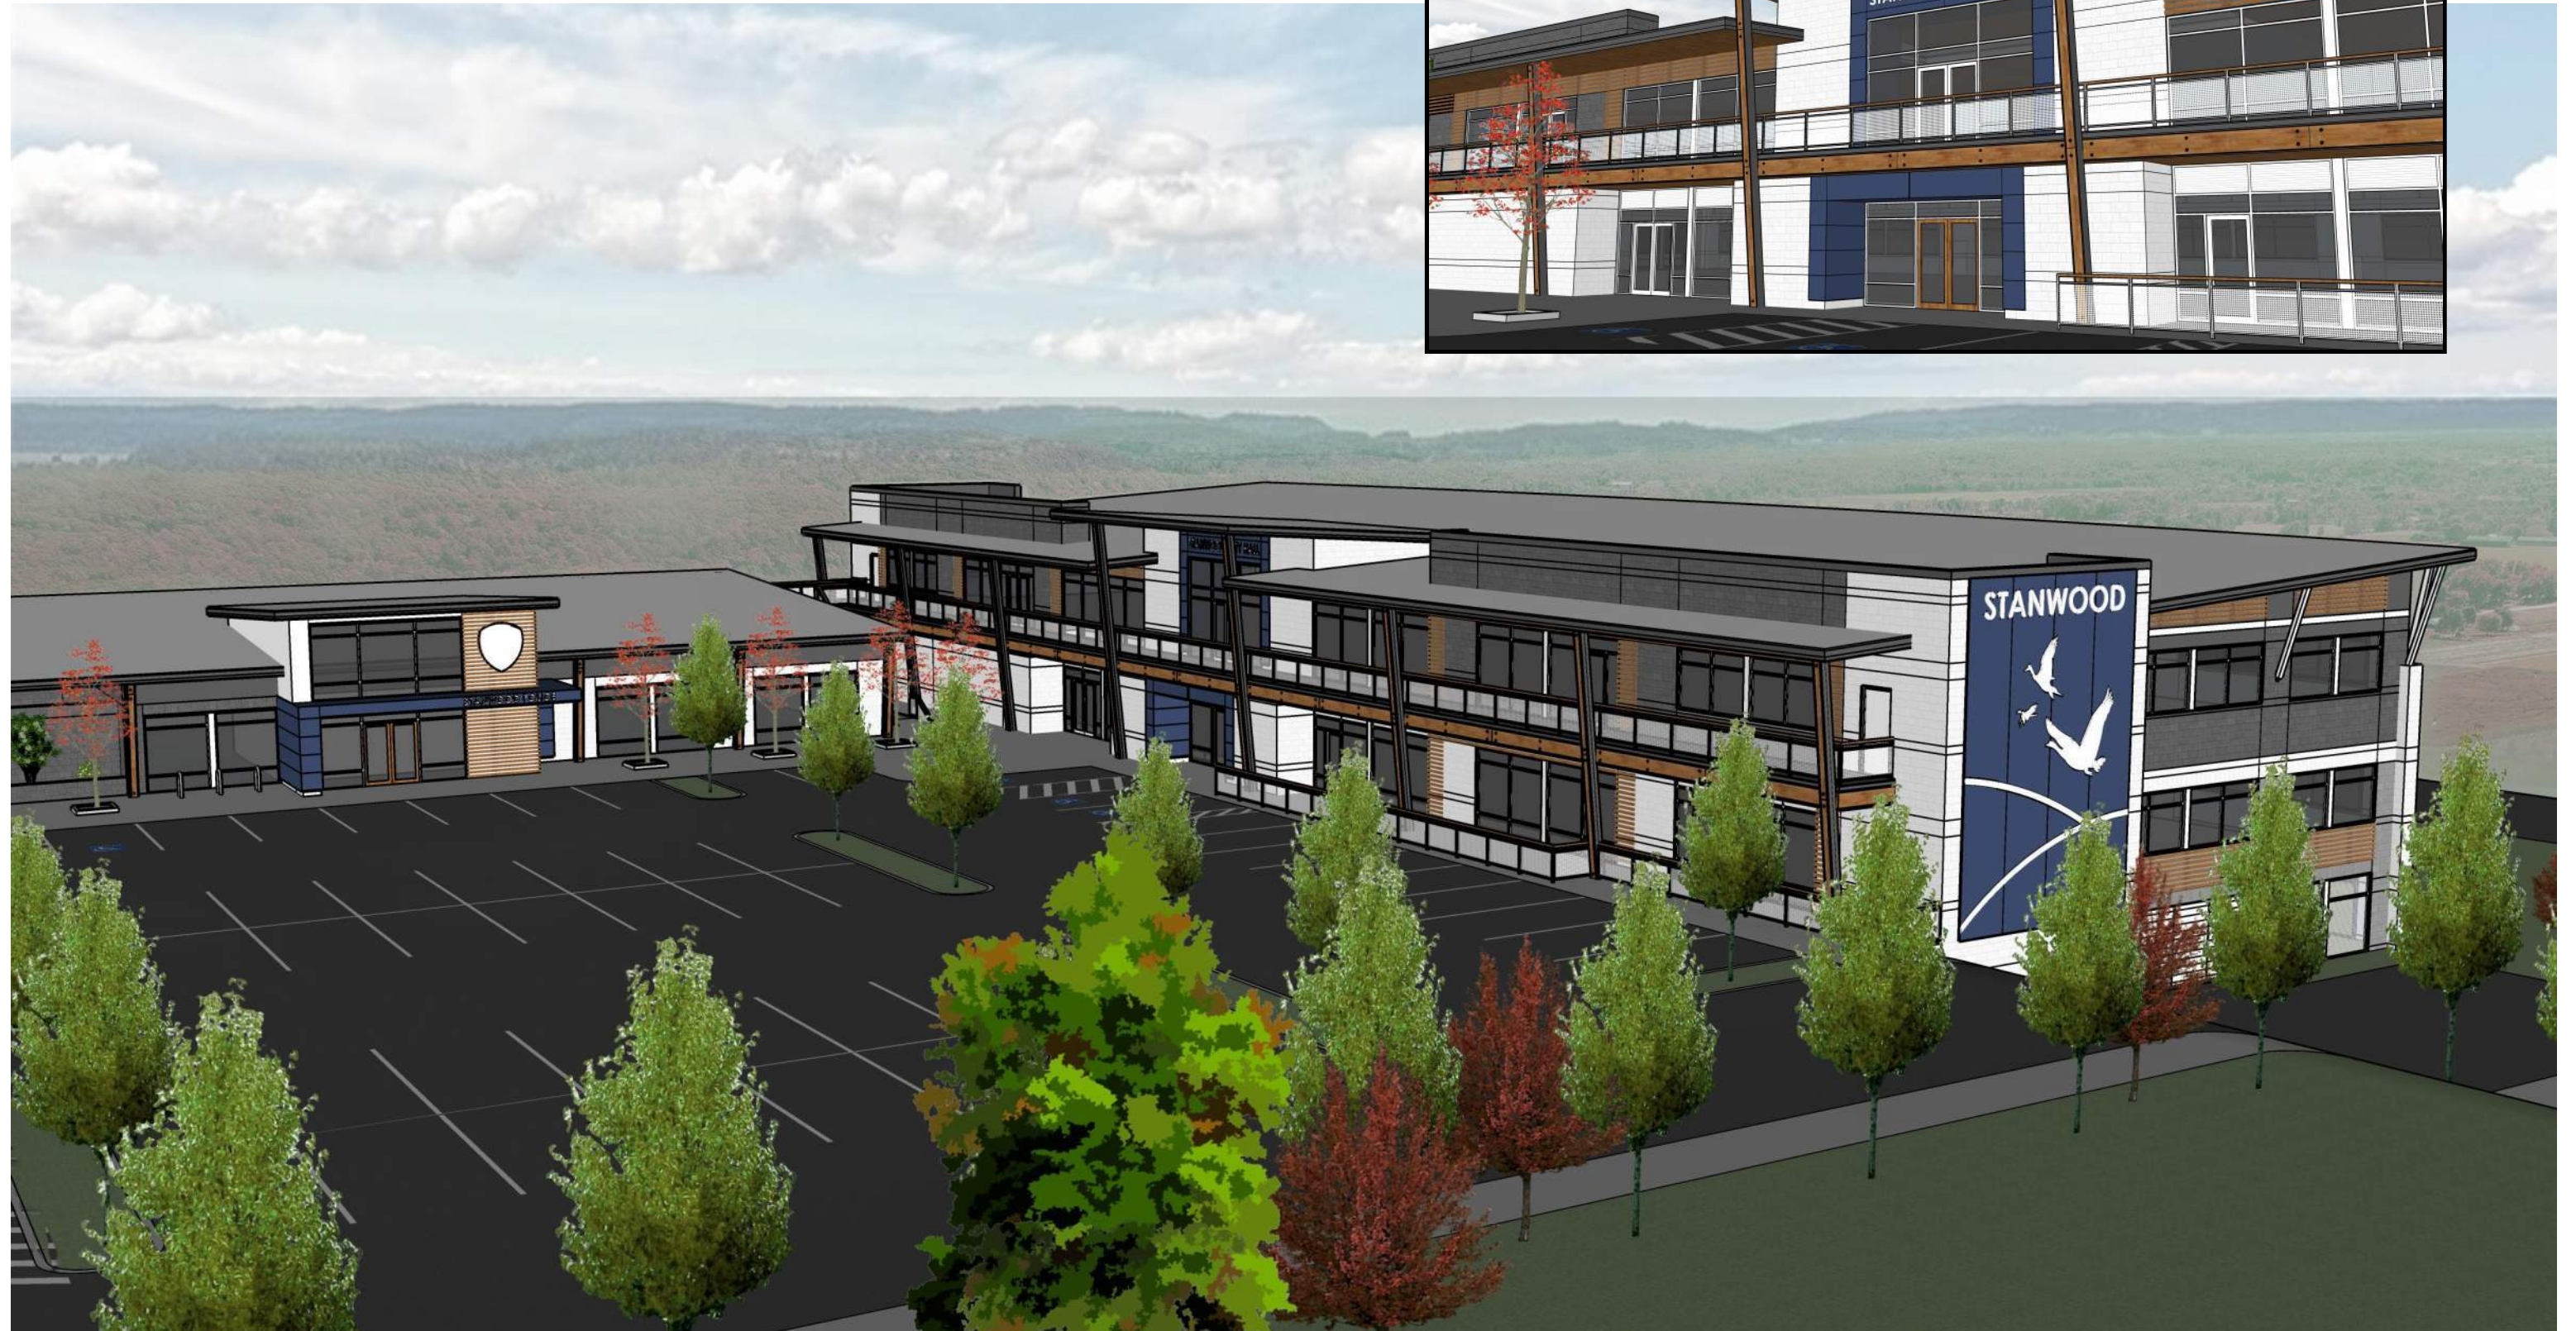
Option #1 Recommended Design Proposal Views

STANWOOD CITY HALL, COUNCIL CHAMBERS AND POLICE

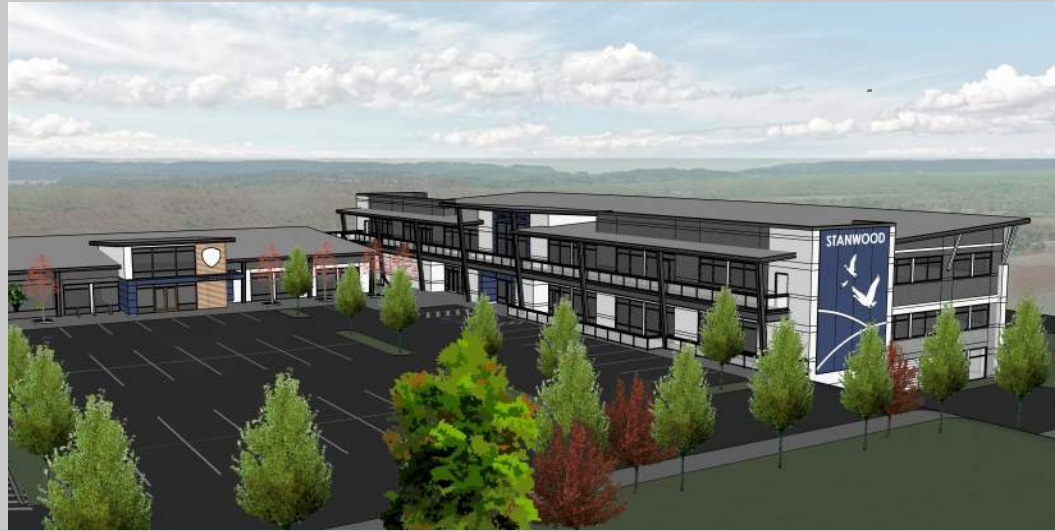
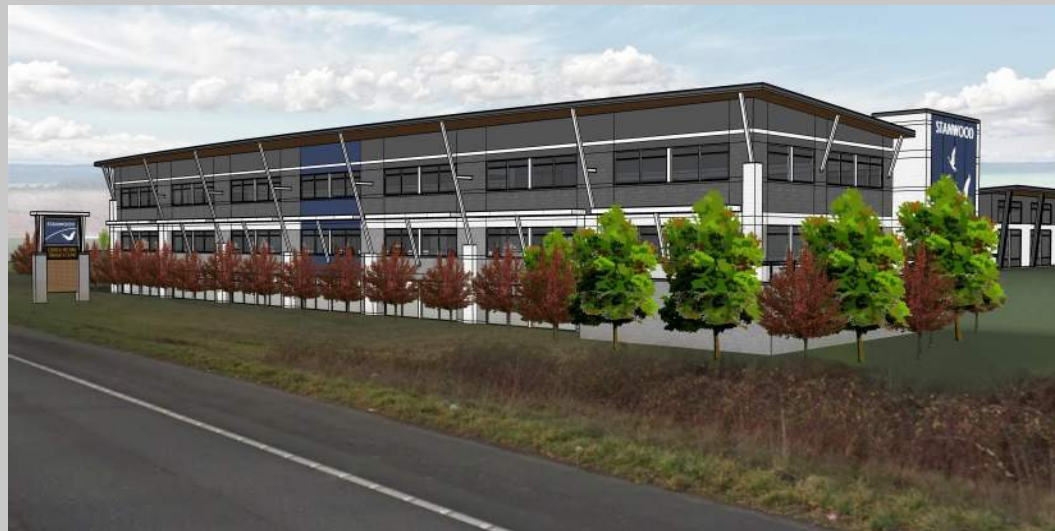
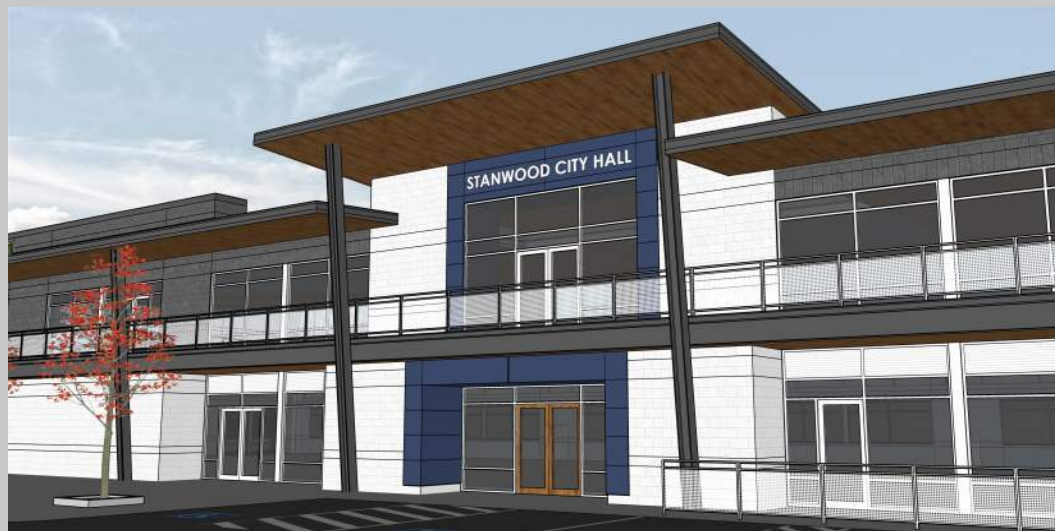
exterior option without laminate wood wall panels

--In lieu of exterior laminate wall panels, paint existing concrete block surface

--Estimated construction savings reduction from option 1 or 2 base: \$455,000

Cost savings can be achieved by eliminating the PV panels and eliminating the laminated wood panels from the exterior upgrade. See the attached cost summary for a comparison of the options. Note that the cost summary does not include the cost of the land purchase.

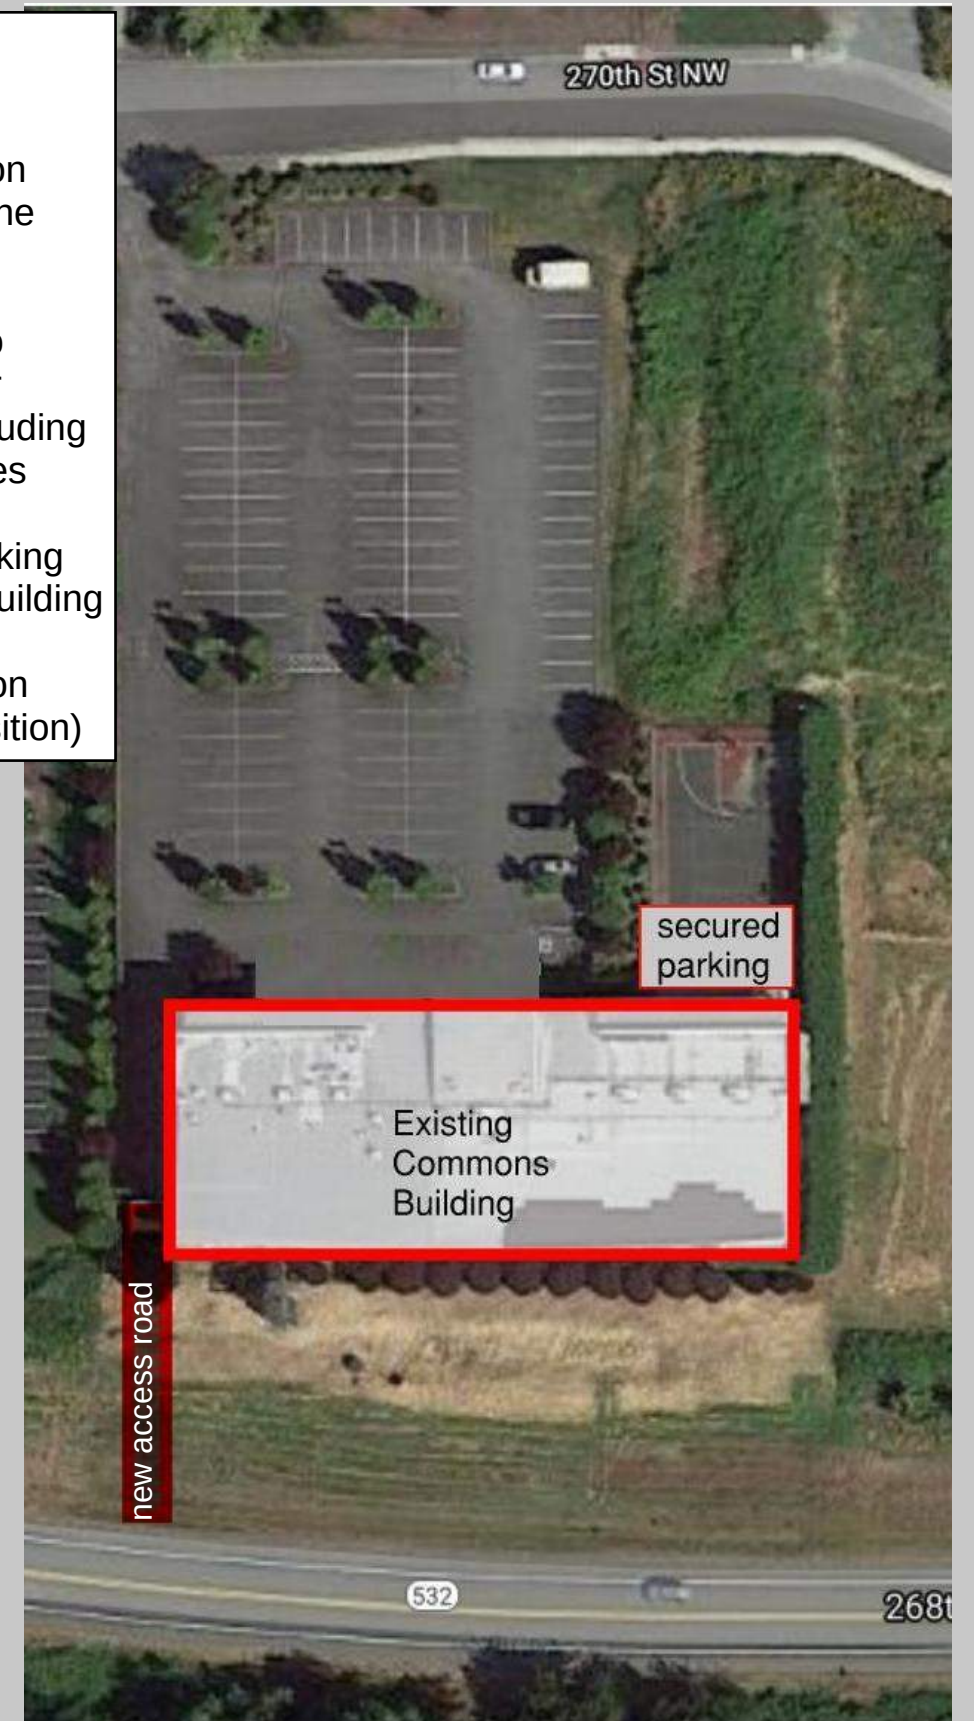
--Upgrade existing building to emergency operations center seismic design standard, including extensive foundation upgrades

--New Sally Port secured parking garage adjacent to existing building

--Estimated cost: \$20.7 million (does not include land acquisition)

- A. New Sally Port secured parking for police.
- B. Renovate existing building area of approximately 12,000 sq. ft. for use as City Hall and Council Chambers.
- C. Renovate existing building area of approximately 5,000 sq. ft. for police.
- D. Seismic upgrade to entire building to make it suitable to use as a police station and emergency options center. Upgrade includes major foundation improvements.
- E. New photovoltaic panels on existing building.
- F. New roof membrane.
- G. Mechanical, electrical and plumbing system retrofits.
- H. Site upgrades: repair and upgrade parking lot, upgrade storm water management, add emergency access road.
- I. Exterior updates: paint, metal panels at entrance, signage, and laminated wood accent panels.

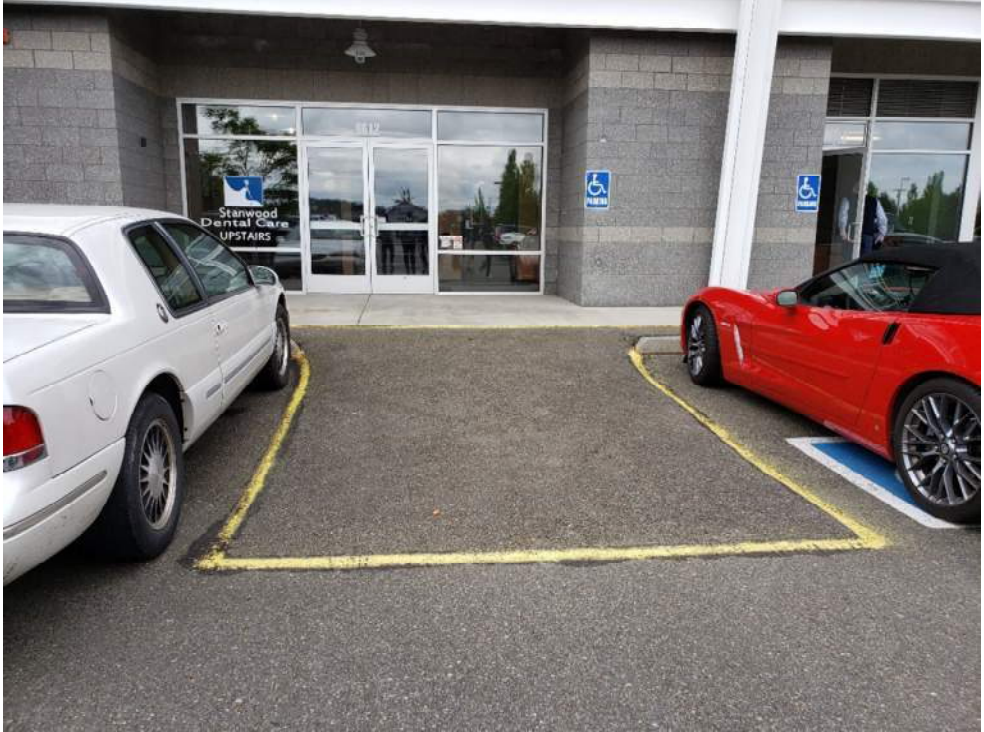
| | Site |
|---|---|
| Accessibility | ADA compliant entrances should be added to new and existing structures. This will include at least three curb ramps, including the replacement of two existing improvised ramps and one new ramp for the new police building. An example of an existing ramp is shown below. |

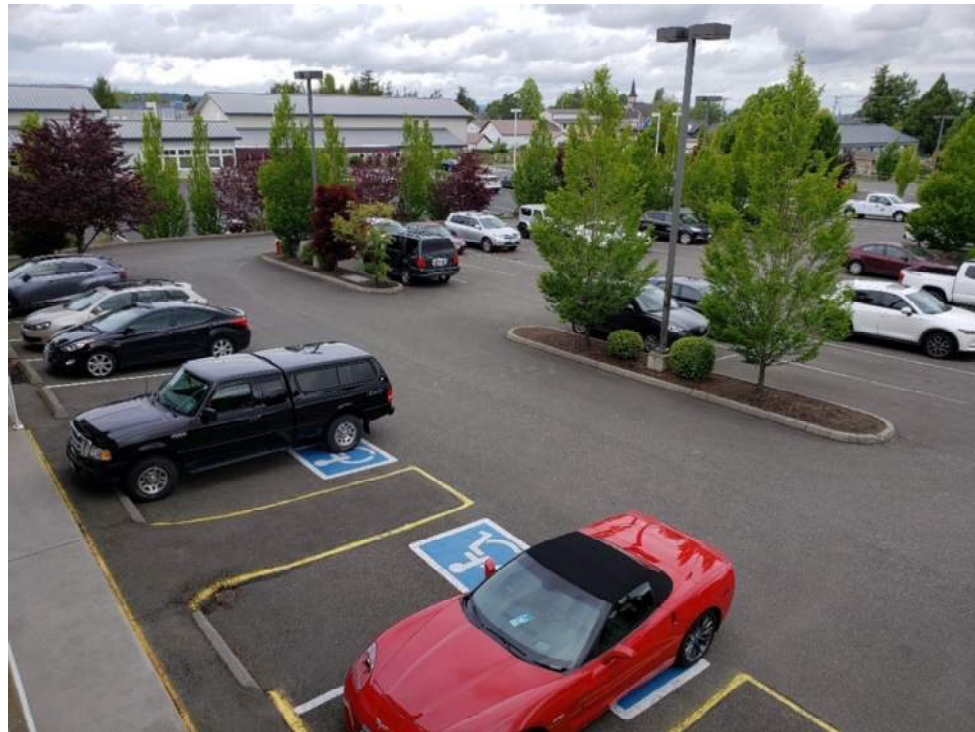
| Civil | |
|---|---|
| Topography and Existing Conditions | The site slopes to the northwest, but also falls off sharply on the east and south sides of the property. There is a stormwater detention pond on the south side of the property and a recessed basketball court approximately eight feet below the parking lot surface on the east side. The primary structure sits just north of the stormwater pond with the parking lot extending north to 270th Street NW. The southern edge of the property abuts SR 532. |

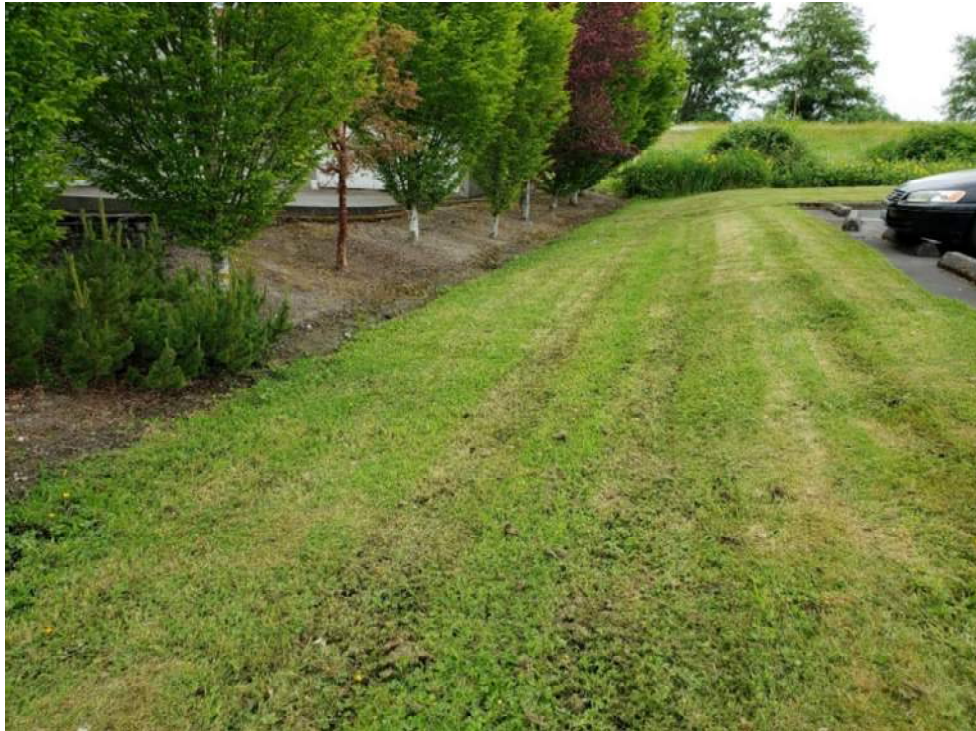
**Drainage Systems** Stormwater runoff from the existing parking lot sheet flows to a curb cut at the northwest corner of the site where a swale (shown below) carries the runoff to the south and into a detention pond.

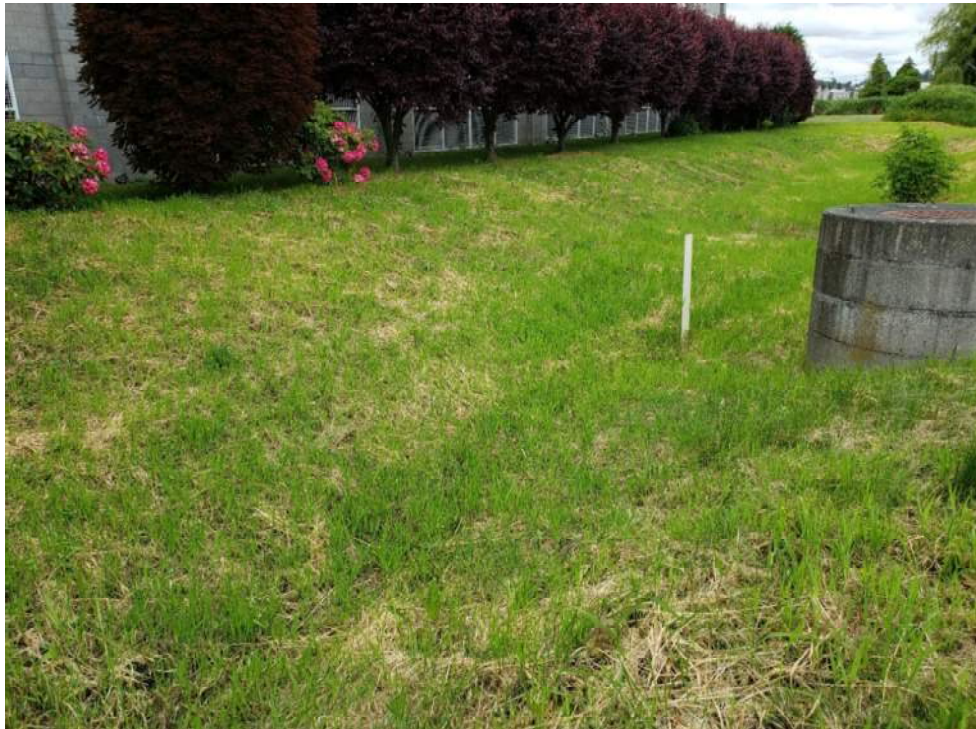
Roof runoff is conveyed directly to the pond (shown below) in downspouts connected to buried PVC pipes.

Except for the basketball court, which evinced ponding, the site drainage appears to be functioning. Since the basketball court is proposed for replacement, no drainage improvements are proposed except those incorporated in the design of the new police station building and auxiliary access point. Per City Engineer Shawn Smith, the site is flow control exempt because it discharges to the Stillaguamish River. The site will, however, be required to provide enhanced water quality treatment. It is the City's preference to use a natural system like a bioretention swale rather than an emerging technology that requires replacement of cartridges. The existing swale along the western edge of the parking lot should be improved to meet the requirements of a bioretention swale. Any target surfaces created by the auxiliary entrance will need to be treated downstream of the existing pond with a new bioretention system.

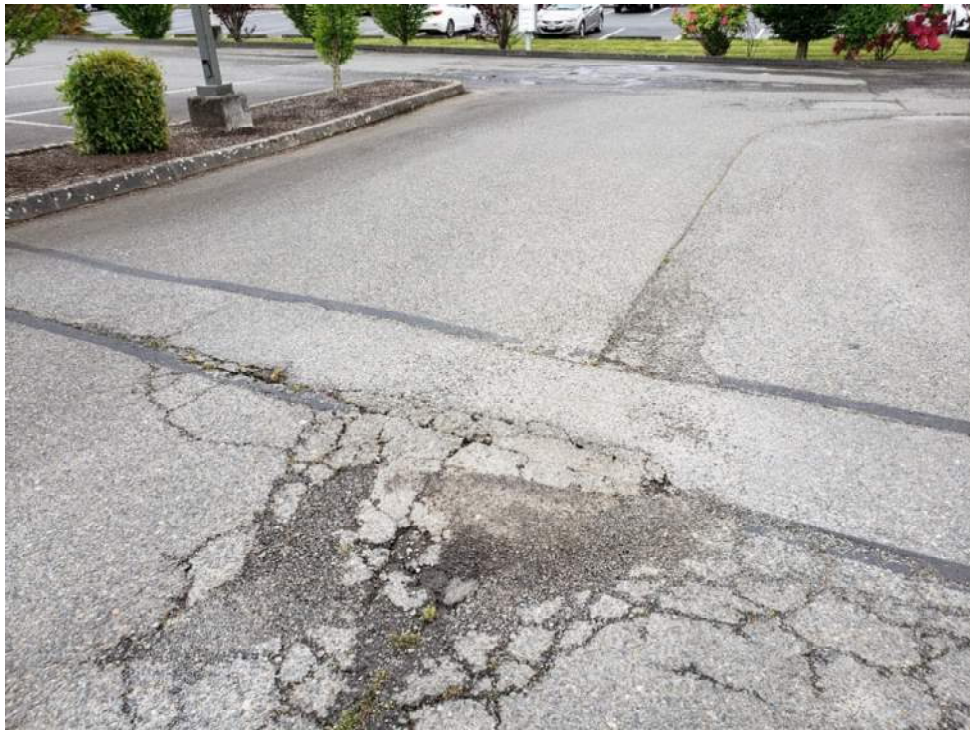
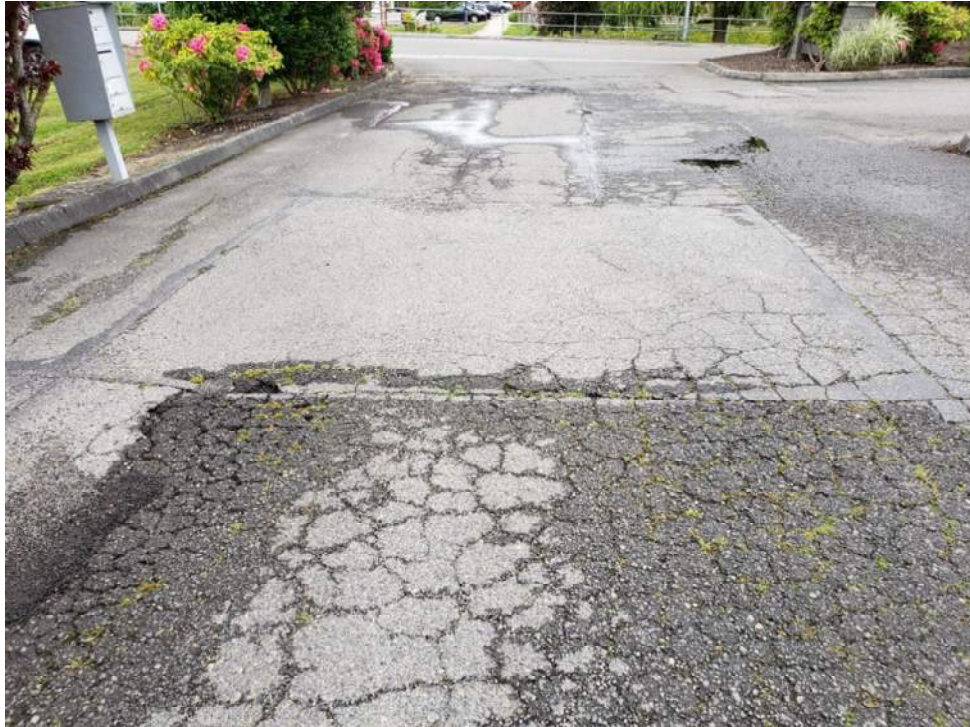
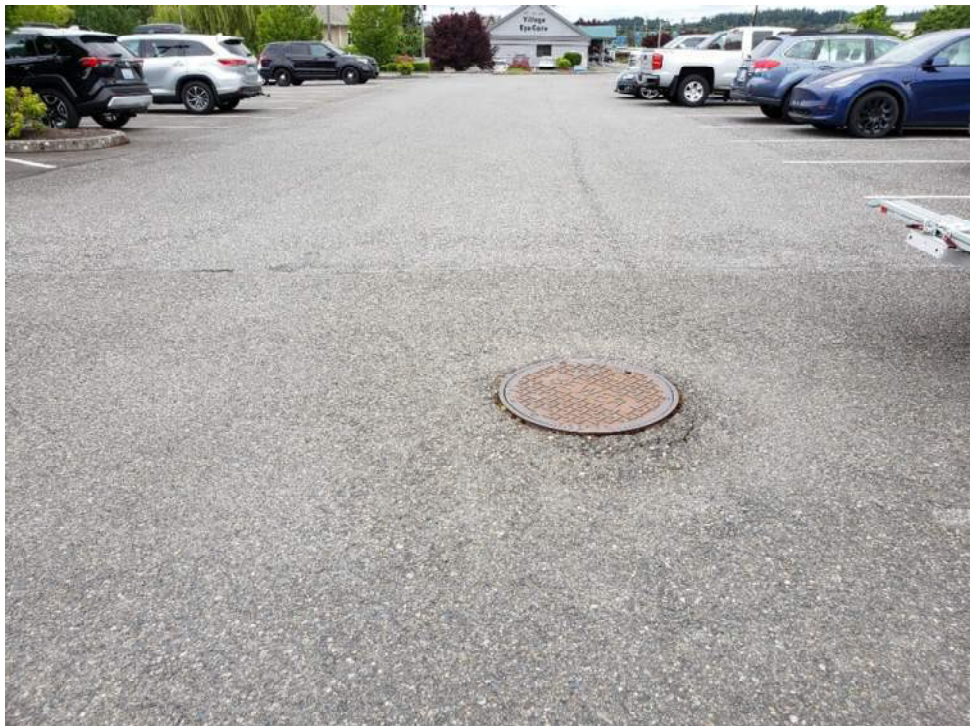
| On-Ste Paving | Parking lot paving exhibits severe damage that will require full-depth repair. The images below give examples of pavement damage and settlement. Curbing is mostly intact but is composed of extruded curb. Where pavement is replaced, it is recommended that the curbs be traffic curb for ease of installation of the new HMA pavement as well as a more sturdy and longer lasting product that can better sustain bumps from vehicle tires. |

According to design plans, the existing pavement section is 2" HMA, 3" CSTC, and 12" gravel base. Geotechnical explorations performed by Associated Earth Sciences, Inc. on July 14, 2021 show that the exiting asphalt section varies across the parking lot from 3" to 6". Since more than 20% of the pavement requires replacement, it is recommended that the entire lot be repaved. At this 20% threshold, unit prices of construction materials likely

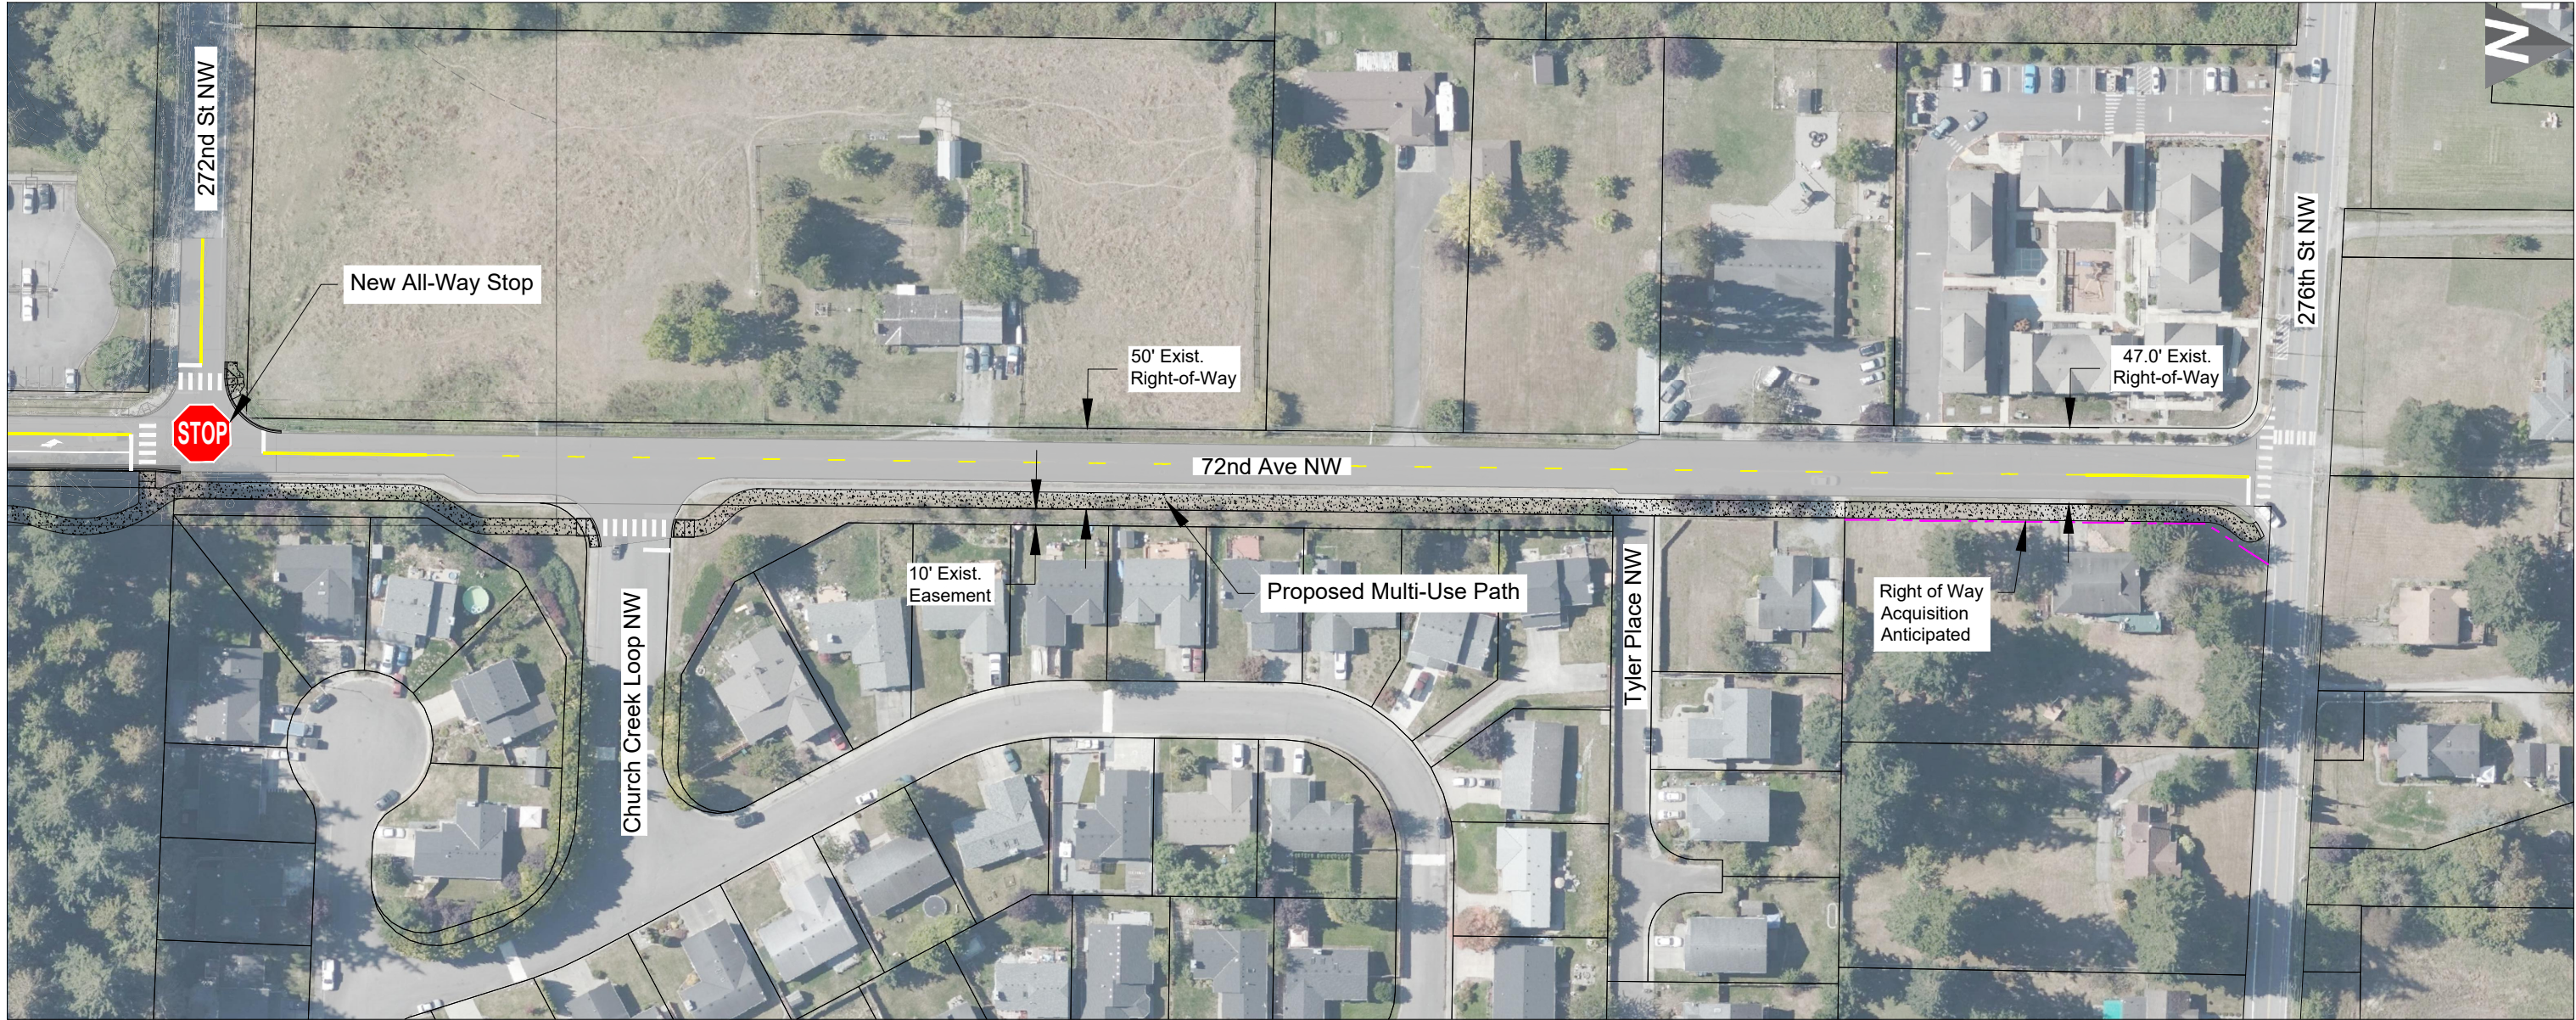
# 72nd Ave NW - Active Transportation Improvements

City of Stanwood - SR532 Bypass

Several other cross-sections were developed and discussed with City Staff. These different concepts all have one traffic lane in each direction, but differed on the type and location of bike facilities. Traditional bike lanes (both directions), uphill-only bike lanes, and shared-lane facilities were considered. The recommended cross-section was chosen to minimize vehicle-bike conflicts and to keep the size of the roadway within the available right-of-way.
